**REPORT
TO
THE HALTON DISTRICT SCHOOL BOARD**

**UPDATED SURVEY OF
ASBESTOS-CONTAINING MATERIALS
DR. CHARLES BEST PUBLIC SCHOOL
3110 PARKGATE CRESCENT
BURLINGTON, ONTARIO**

September 2014

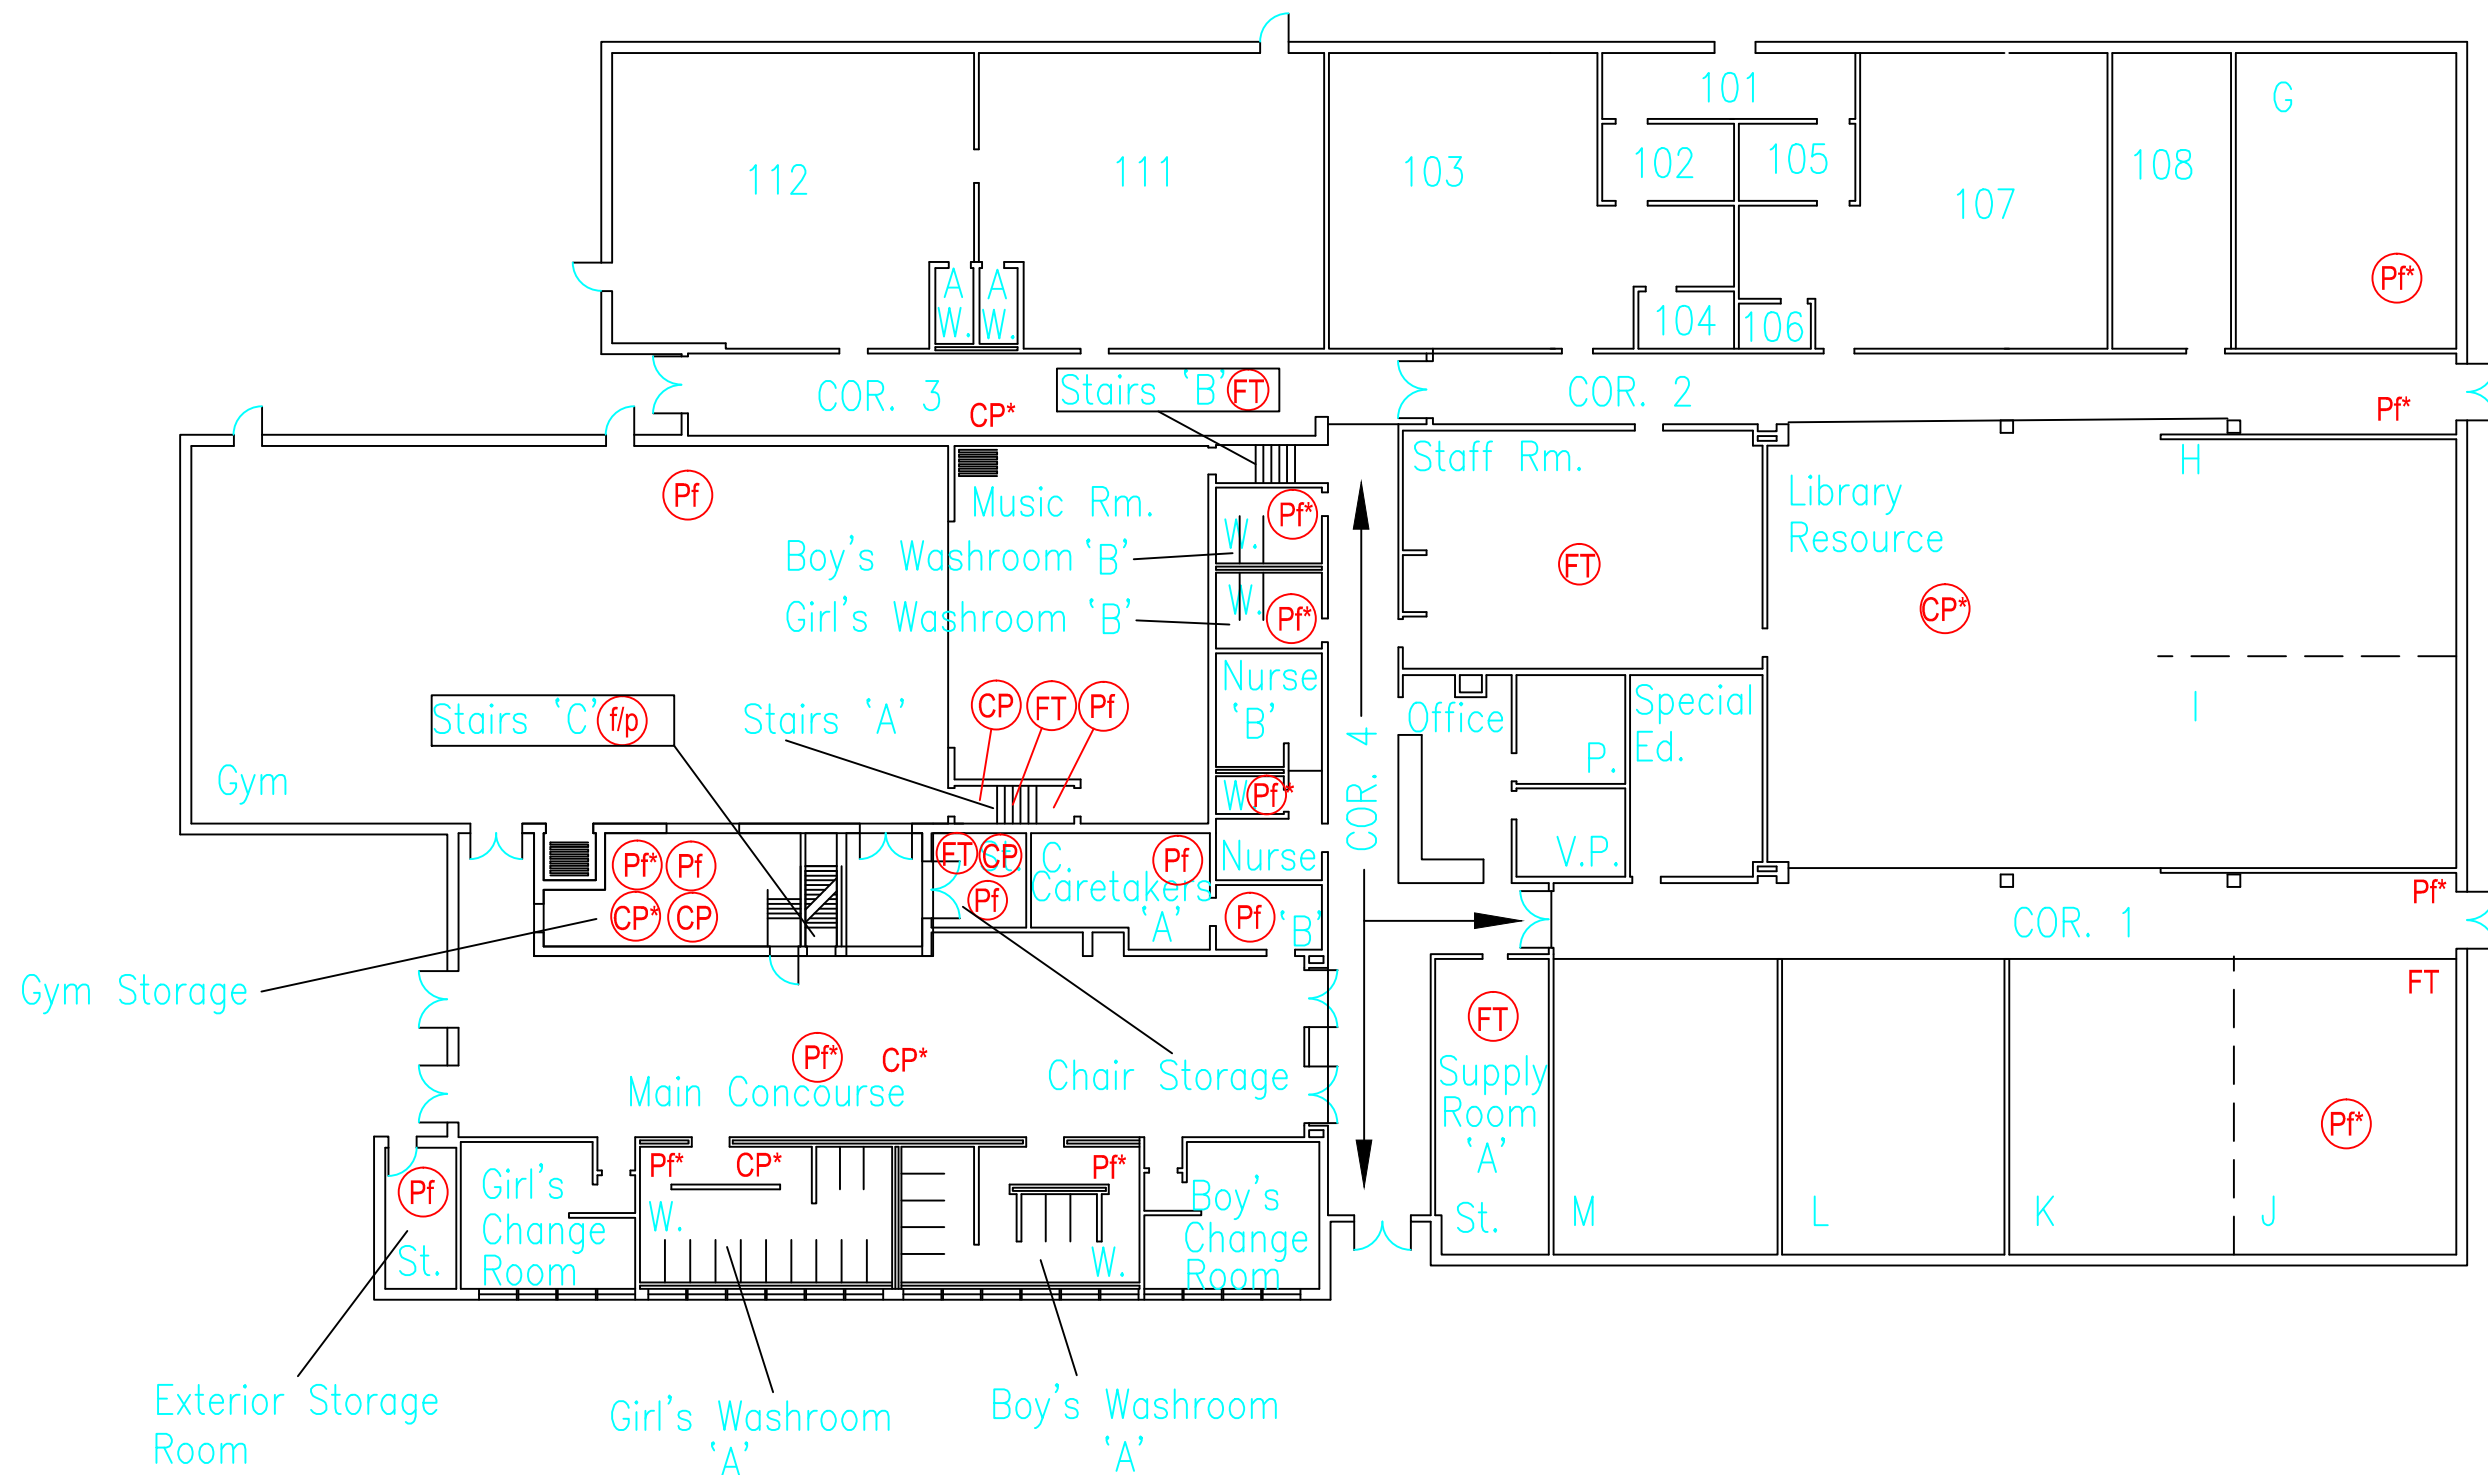
DR. CHARLES BEST PUBLIC SCHOOL
UPDATED SURVEY OF ASBESTOS-CONTAINING MATERIALS
 LOCATION OF ASBESTOS CONTAINING MATERIALS
 FIRST FLOOR

- Thermal insulation applied to pipe fittings above and below ceilings throughout the facility; and
- Spray-applied cementitious fireproofing on roof decking in Stair C and Second Floor Mechanical Room.

- 12” x 12” vinyl floor tiles throughout the facility; and
- Cement piping above and below ceilings throughout the facility.
