SURVEY OF ASBESTOS- CONTAINING MATERIALS

J.M. DENYES PUBLIC SCHOOL

215 THOMAS STREET, MILTON, ONTARIO

Updated January 29, 2018

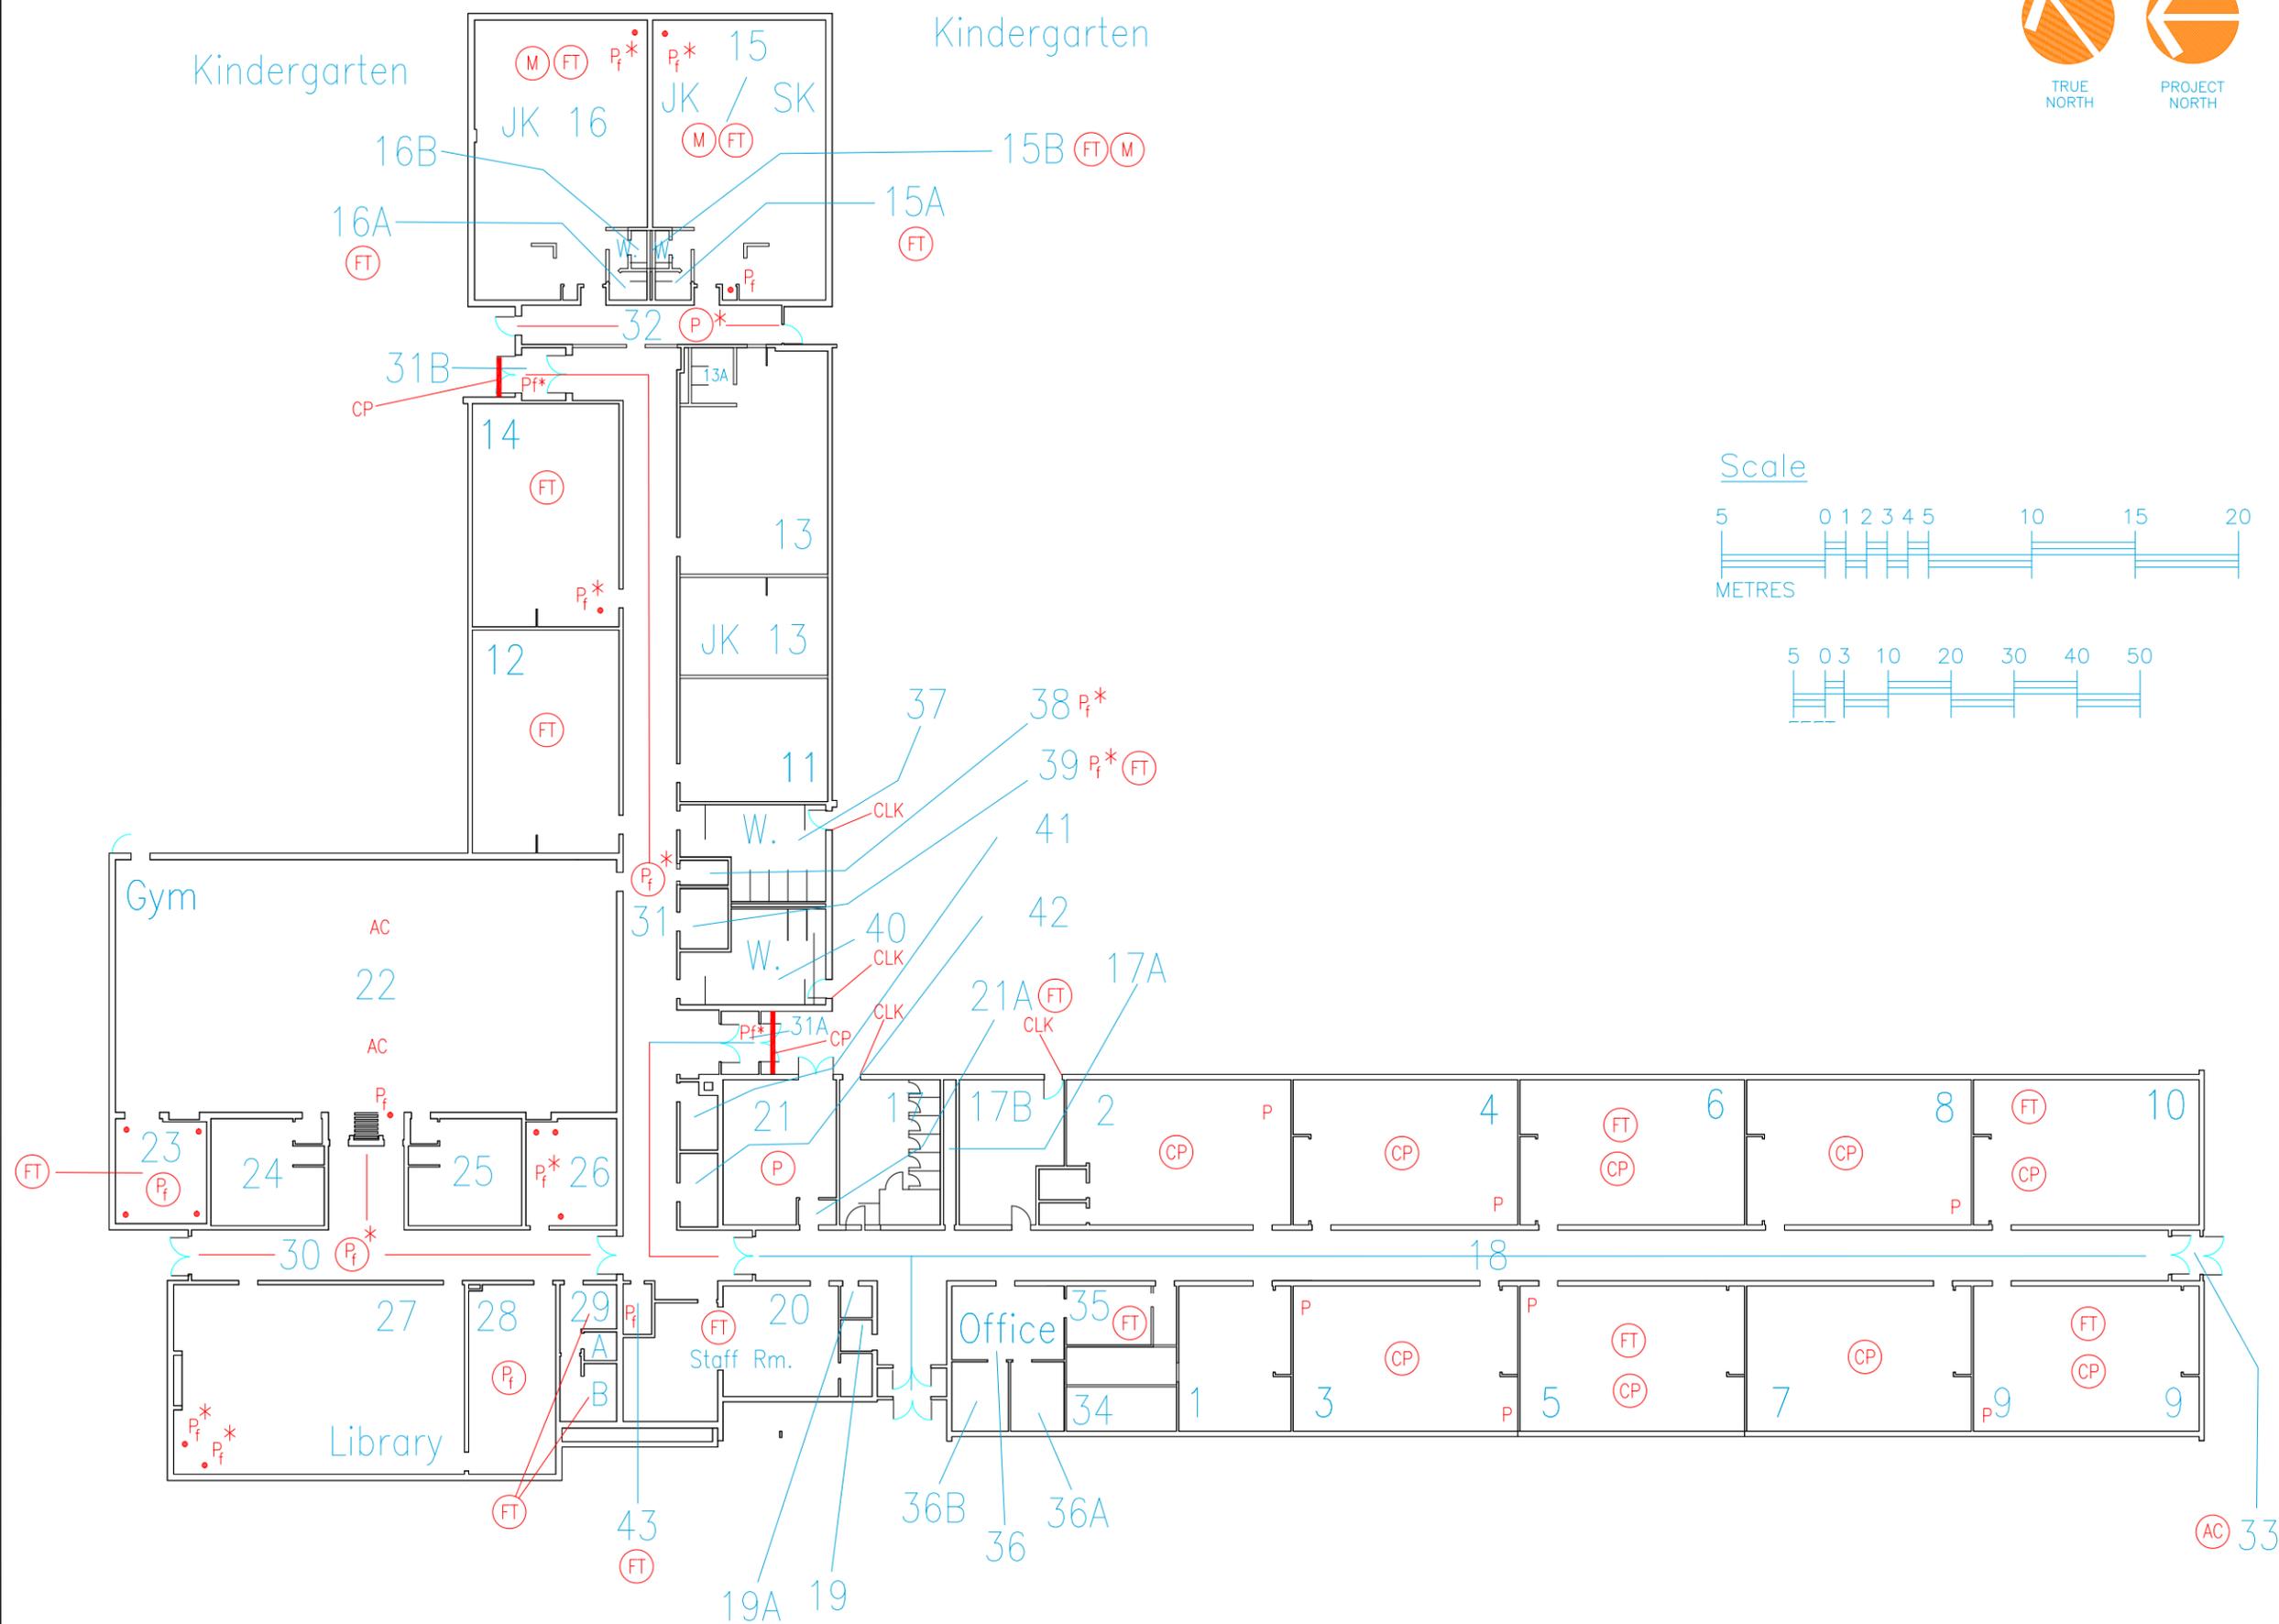
INTERIORS OF ALL FIRE DOORS ARE ASSUMED TO CONTAIN ASBESTOS.
