**REPORT
TO
THE HALTON DISTRICT SCHOOL BOARD**

**SURVEY AND ASSESSMENT OF
ASBESTOS-CONTAINING MATERIALS
PAUL A. FISHER PUBLIC SCHOOL
BURLINGTON, ONTARIO**

Revised August 2013

Re: **Revised Survey of Asbestos-containing Materials**
Paul A. Fisher Public School
Burlington, Ontario

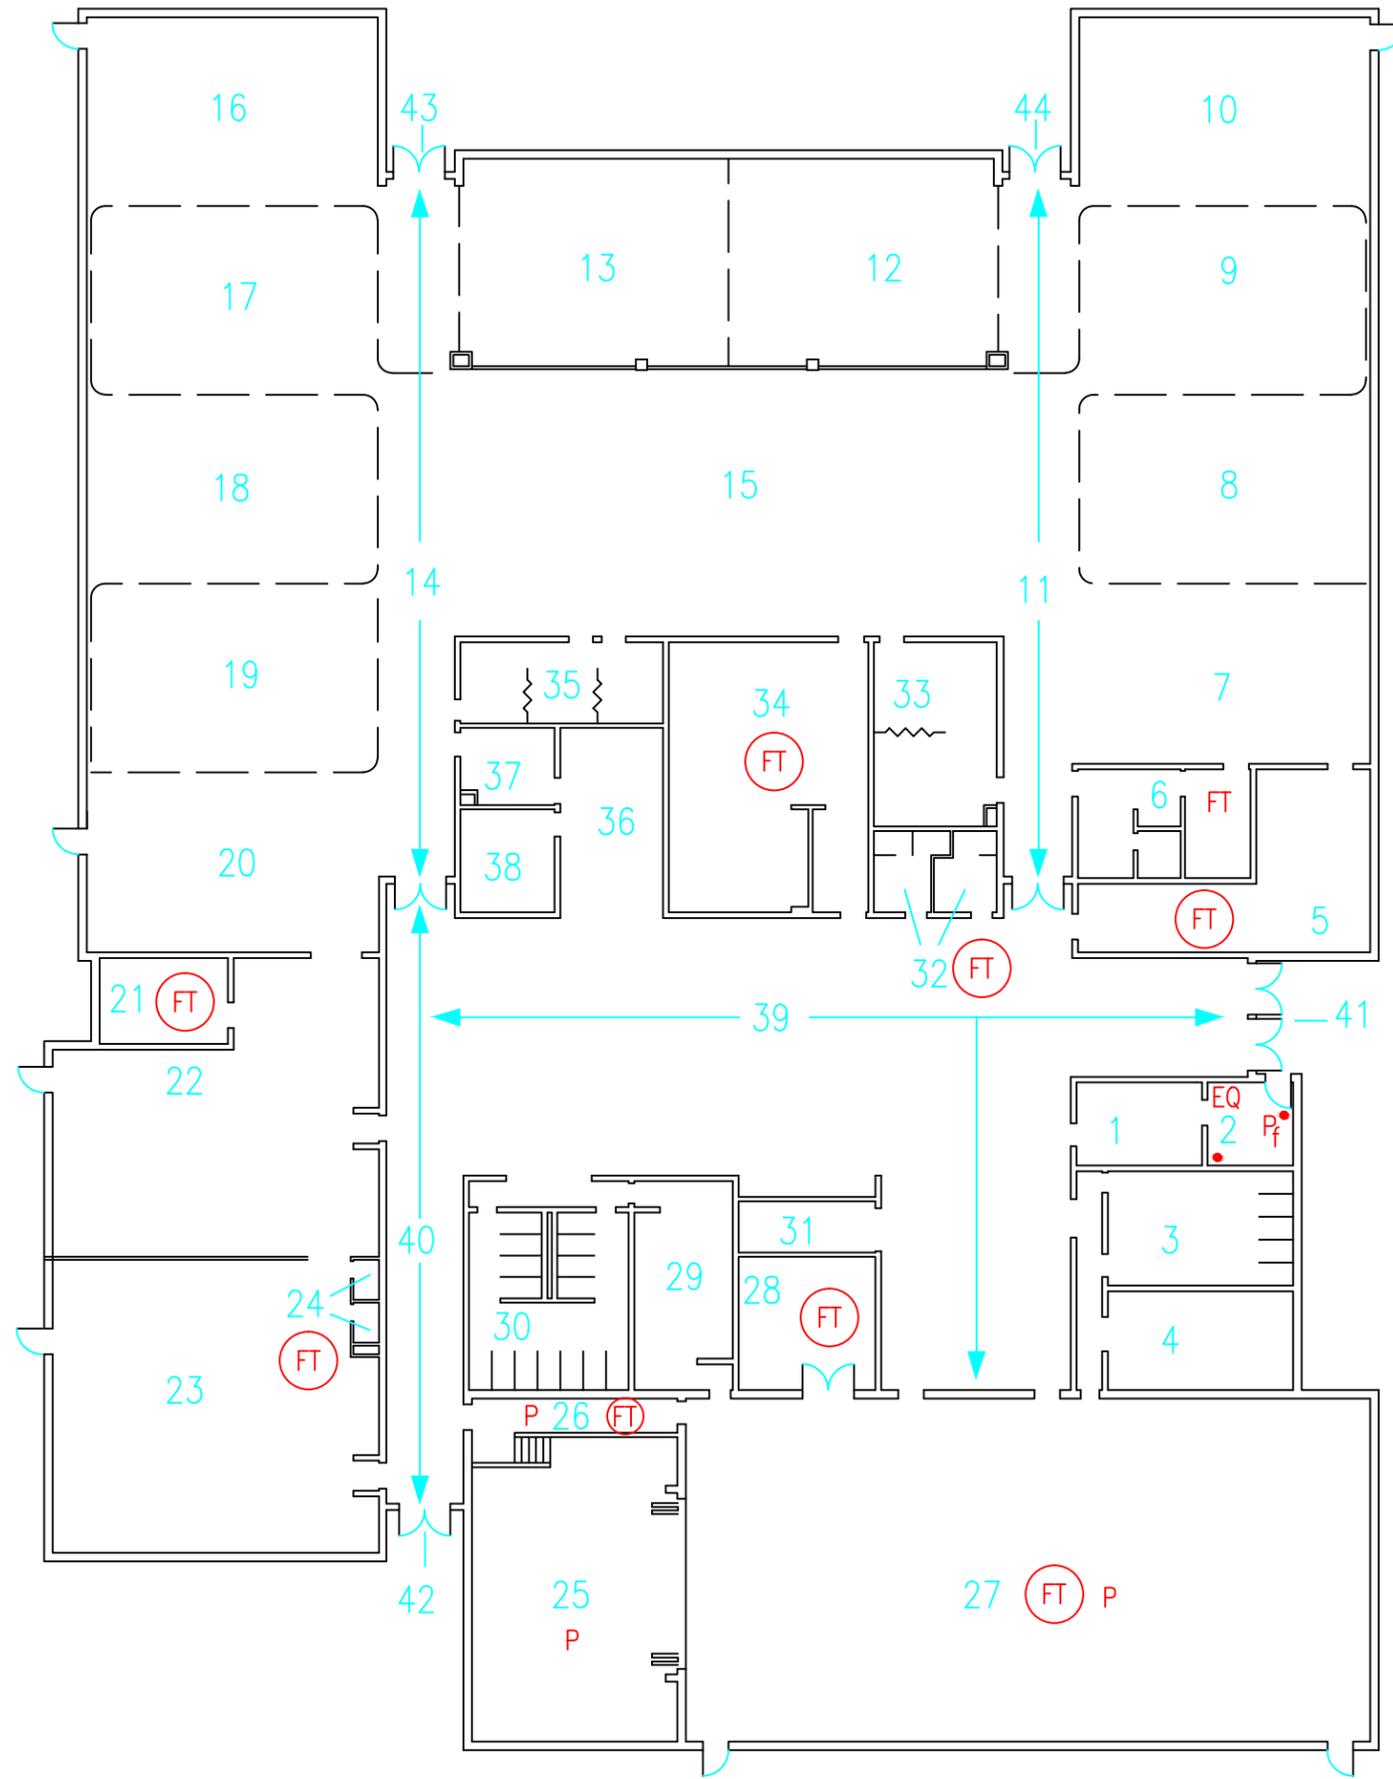
Date: JULY 2013 Scale: N.T.S Drawing No: 701931-000-1

- thermal insulation on cold water meter and pipe fittings in the Mechanical Room (Area 2); and
- thermal insulation suspected to be on rain drain piping in Areas 25, 26 and 27 (inaccessible due to height).

Locations of friable asbestos-containing materials and vinyl flooring suspected of containing asbestos are identified on the attached floor plan(s). Locations of non-friable asbestos cement products are identified in the room-by-room summary sheets.

LOCATION OF ASBESTOS CONTAINING MATERIALS

FIRST FLOOR
