**REPORT
TO
THE HALTON DISTRICT SCHOOL BOARD**

**UPDATED SURVEY OF
ASBESTOS-CONTAINING MATERIALS
BURLINGTON CENTRAL HIGH SCHOOL
BURLINGTON, ONTARIO**

September 2014

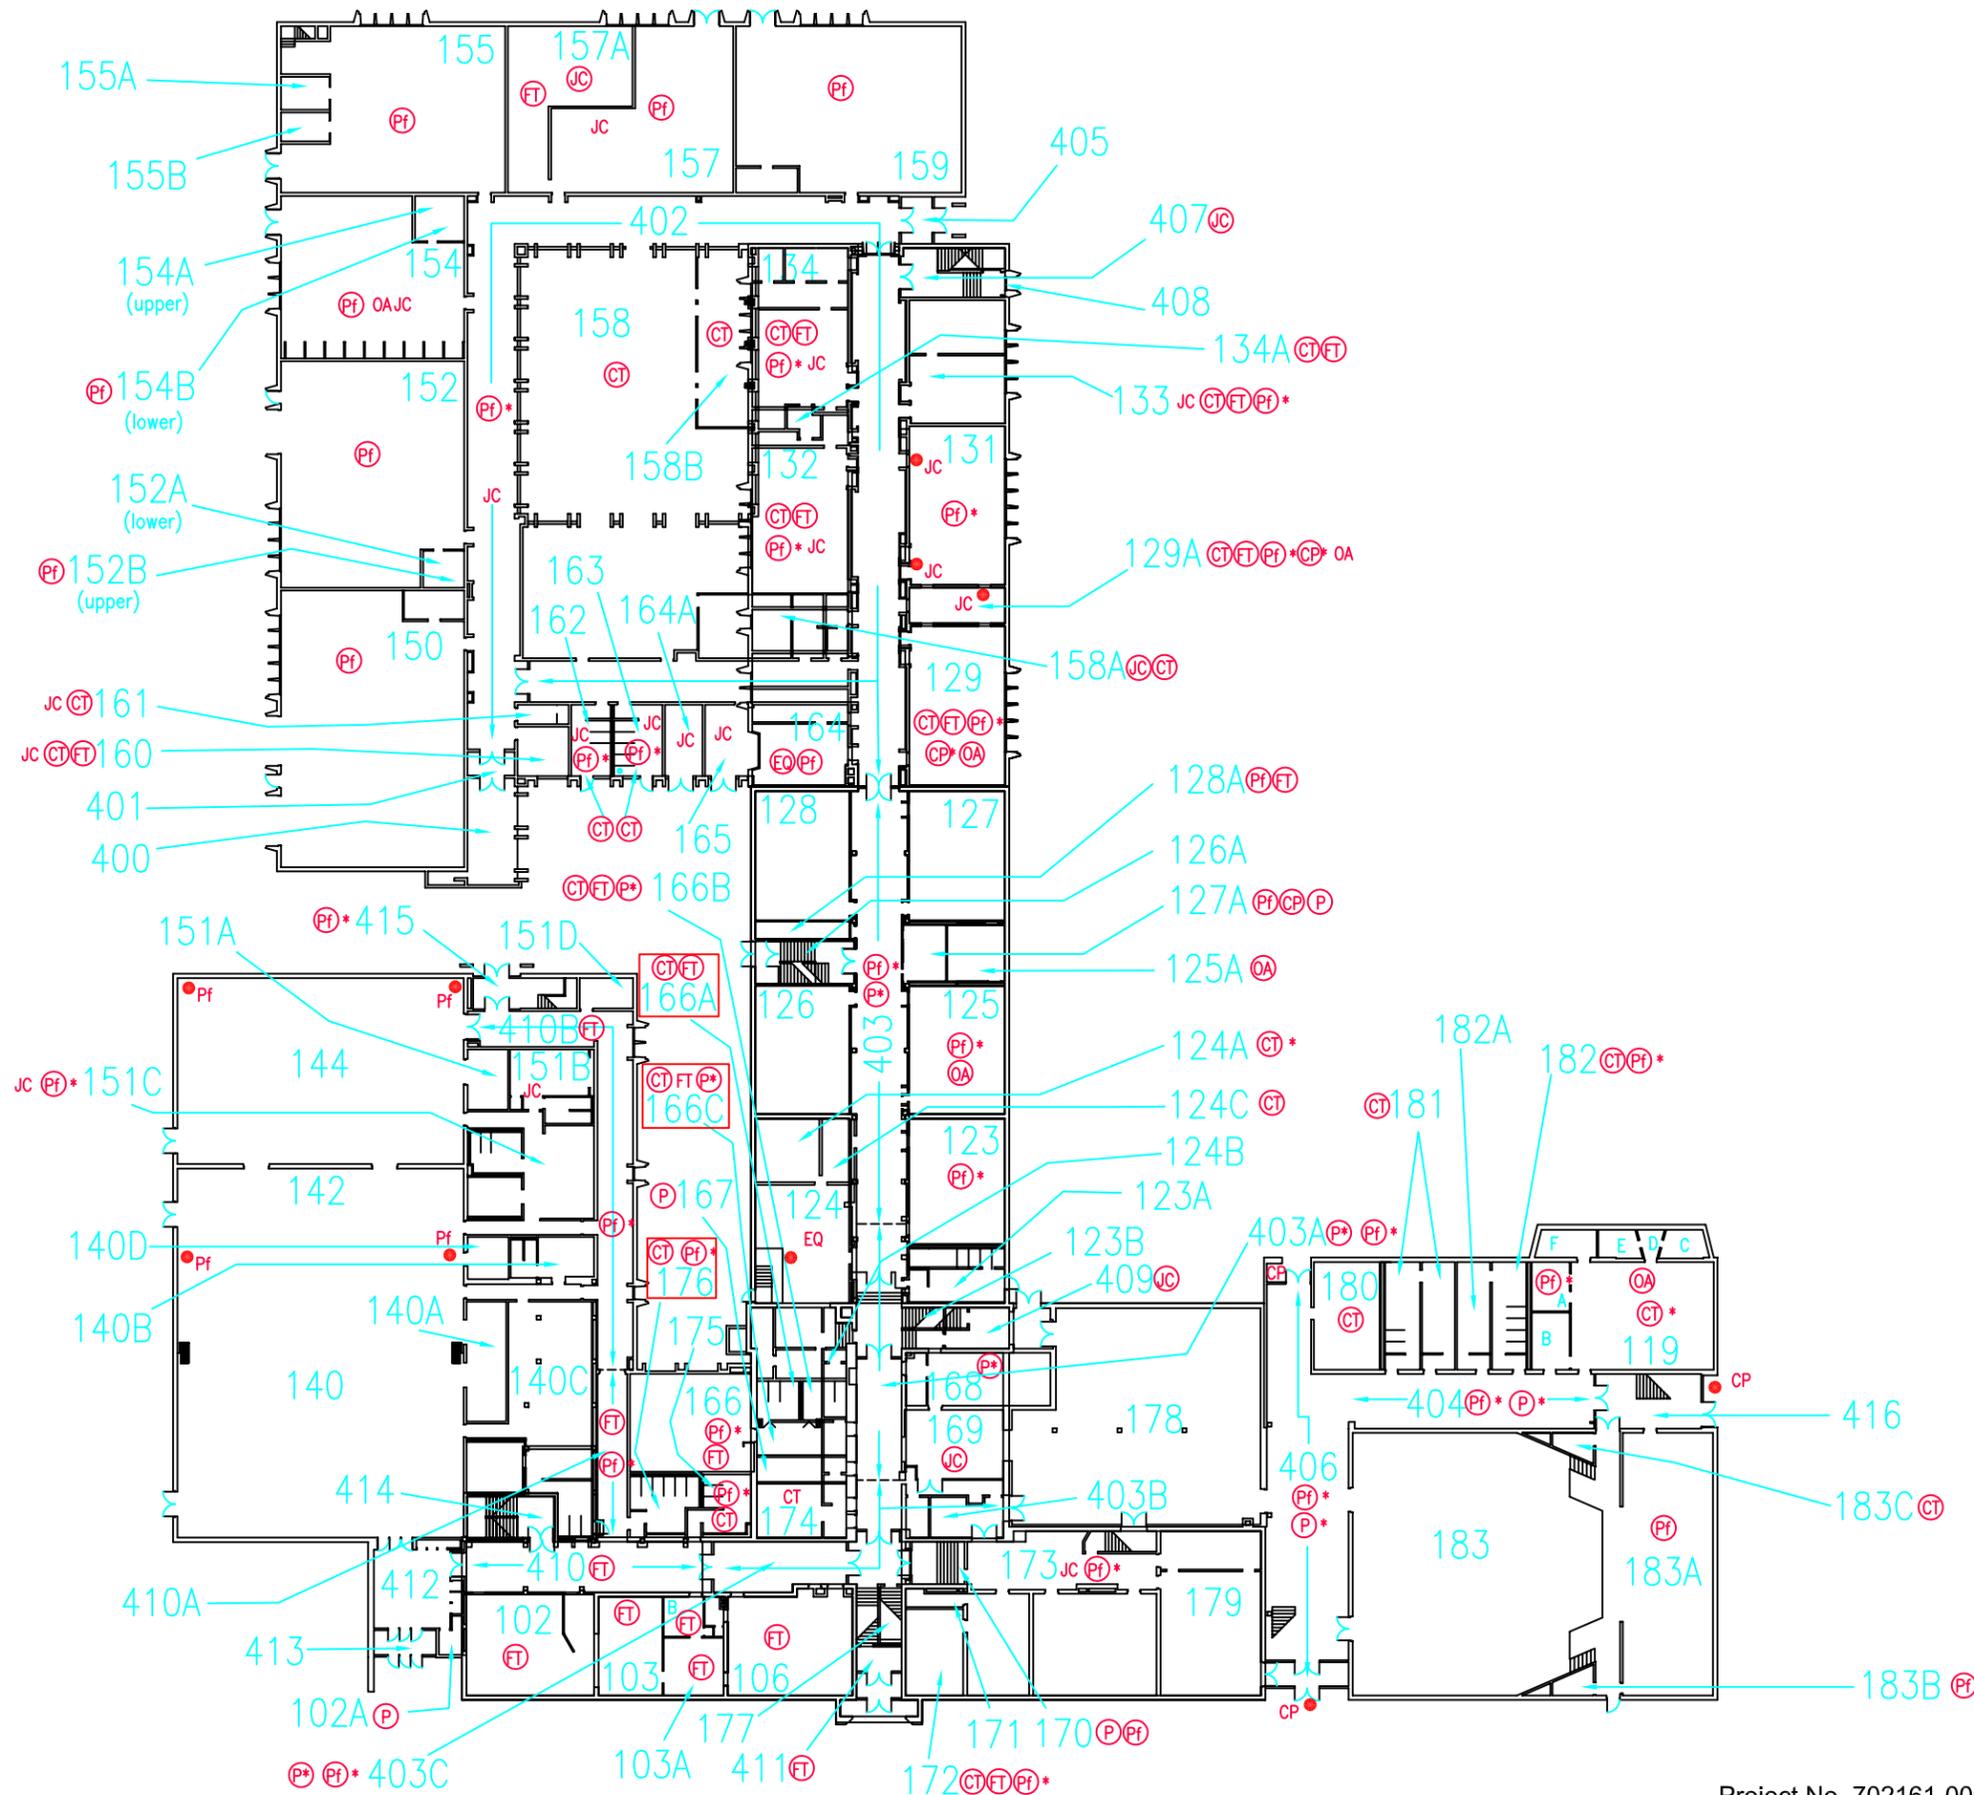
HALTON DISTRICT SCHOOL BOARD
LOCATIONS OF ASBESTOS-CONTAINING MATERIALS
 BURLINGTON CENTRAL HIGH SCHOOL
 BURLINGTON, ONTARIO
 FIRST FLOOR PLAN
